# Inspection Report

**Wake Tech Class**

**Inspection Address – 105 Clay Ridge Way**

**Performed on November 3, 2010**

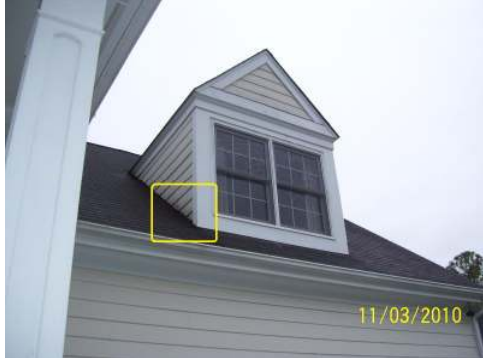
3. There was damaged fiber cement siding on the left-front corner of the front-right dormer (Picture). The damaged siding could be an indication that it has absorbed water. The siding was installed in contact with the roof, which could allow it to absorb water. Typically, the manufacturer requires 1-2 inches of clearance between the siding and the roof. The siding on the dormer needs to be repaired/replaced by a qualified contractor.

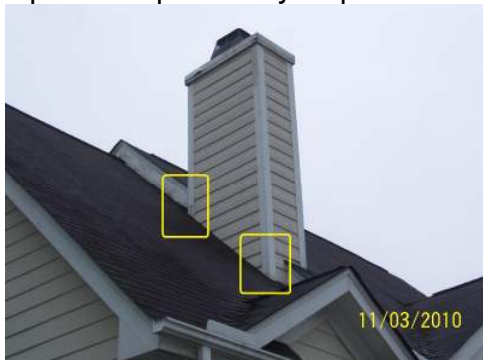
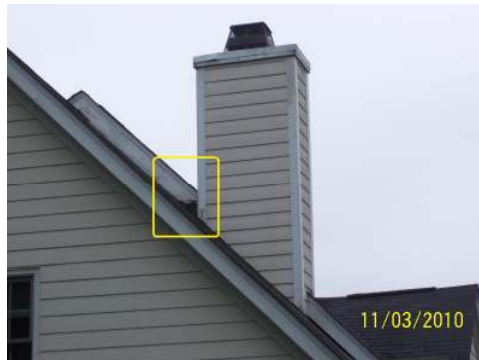
4. There was decayed wood/trim in the following areas: back-left corner of the chimney (Picture); rake board at the back of the chimney (Picture); wood/trim at bottom corners of the back door. These areas could not be reached to probe. The decayed wood/trim can allow water infiltration, which could cause decay of the structural components behind the cladding. There was missing paint on the front-left corner of the chimney (Picture), which could allow the wood/trim to absorb water and decay. The wood/trim needs to be repaired/replaced by a qualified contractor.

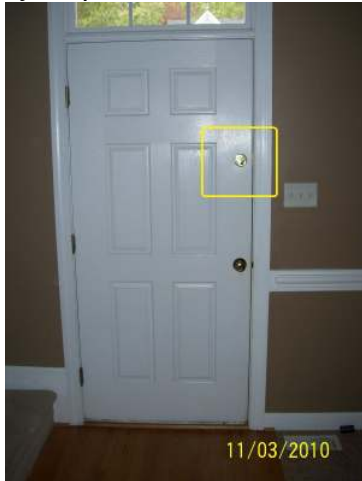
6. There was a deadbolt lock on the exterior doors that was about five feet high from the floor (Picture). Small people and/or children may not be able to reach the deadbolt lock, which is a safety hazard during a fire and/or emergency. The doors need to be repaired/replaced by a qualified contractor.

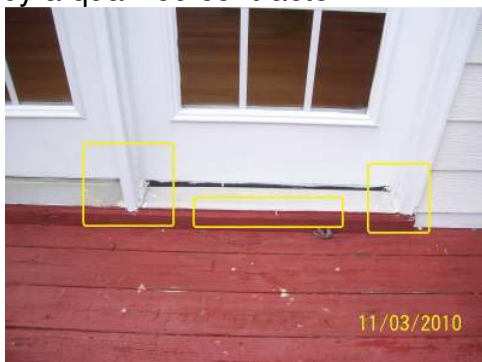
8. There was no sealant or factory sealant installed on the exterior doors where the wood door jamb met the metal threshold (Picture of back door as an example). Typically, the factory sealant is removed after the door is installed and the seams are sealed on-site. There was no sealant along the bottom of the threshold (Picture of back door as an example). The lack of sealant can allow water infiltration, which could cause decay. The front door was covered by porch roof, which will limit the amount of water that gets on the threshold. There was no roof over the back door. The exterior doors need to be repaired by a qualified contractor.

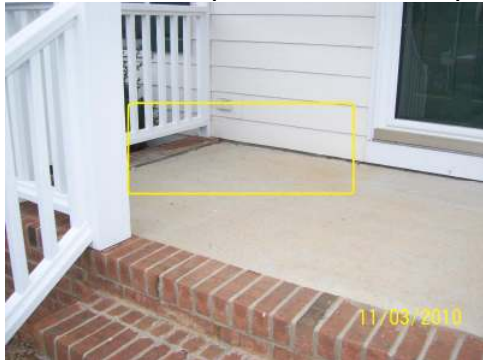
9. There was a masonry front porch with a concrete floor, masonry steps, wood rails and square/hollow columns. The porch was closed/filled and there was no view under it. The concrete floor had settled and sloped toward the house (Picture). This can allow water to flow under the porch. The front porch needs to be repaired by a qualified contractor.

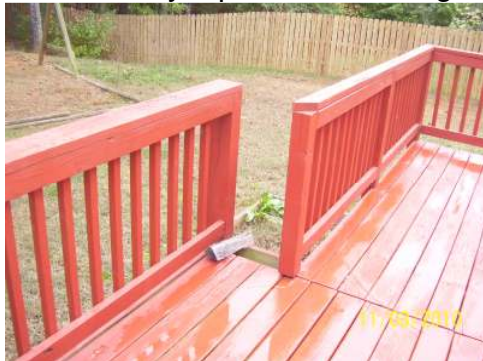
10. There was a wood deck with wood steps/rails/columns/posts that was bolted to the house and had visible flashing. The original deck had an additional added to it. The new back section of the deck had its joists supported by joist hangers. The joist hangers were installed with screws. The joist hangers were smaller than the joist and may not be sized properly. The joists were installed two feet apart. The back band of the new section was a single band. The deck had a loose left rail and a missing section of rail in the back-center (Picture). There were steps on the back deck that were loose and would move and had no rails. The deck construction was not typical and could fail. The deck needs to be evaluated by a professional engineer and repaired as necessary by a qualified contractor.

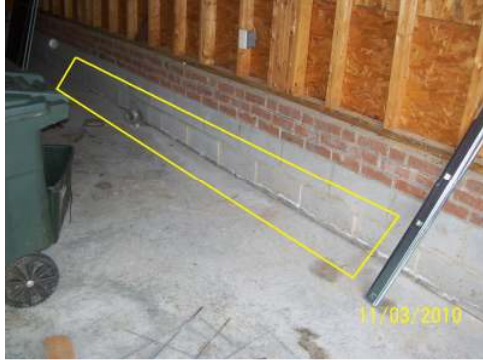
11. There was a two-car garage on the front of the house. There was efflorescence on the right wall of the garage (Picture). The efflorescence is an indication of moisture in the block wall. See below for comments related to the exterior grade that could contribute moisture in that area. After the exterior grading is repaired, the wall needs to be monitored for changes.

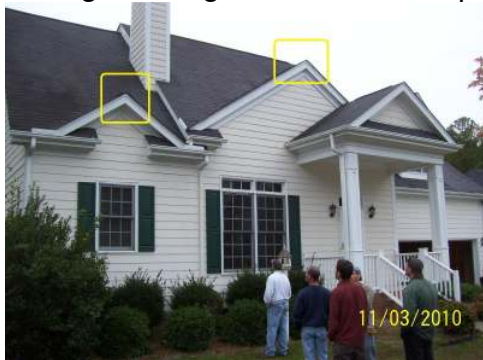
13. There were damaged shingles in the following locations: right edge ridge shingle; front-left lower, front edge ridge shingle (Picture); front-center upper gable, front edge ridge shingle (Picture). Damaged shingles can allow water infiltration, which can cause decay. The damaged shingles need to be replaced.

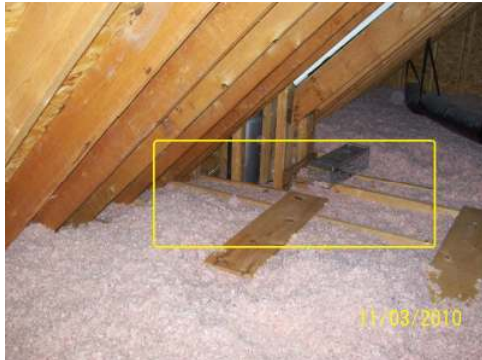
15. The loose fill insulation had been compressed in the front-center of the attic beside the fireplace by an animal (Picture). There was an animal trap in the attic but there were no signs of an animal in the attic during the inspection. The insulation had also been compressed where people had walked through the attic. These areas were not properly insulated, which can make it difficult for the HVAC system to heat/cool the floor under the attic. The attic insulation needs to be repaired by a qualified contractor.

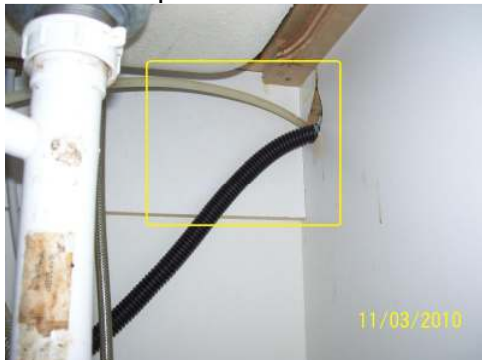
17. The dishwasher drain pipe did not loop up to the top of the cabinet (Picture). The current installation can allow dirty water from the sink to drain into the clean environment of the dishwasher. The dishwasher drain needs to be looped up to the top of the cabinet and secured in place.

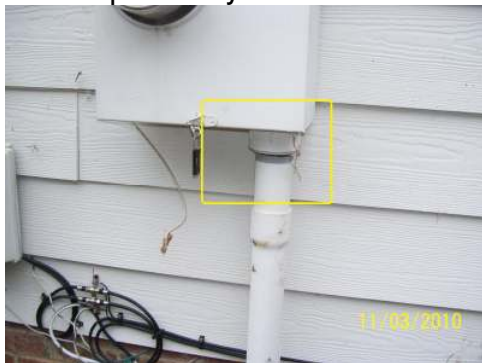
23. The service entrance conduit was loose where it connected to the electrical meter (Picture). This can allow water into the conduit, which creates a shocking hazard. The conduit needs to be repaired by a licensed electrical contractor.

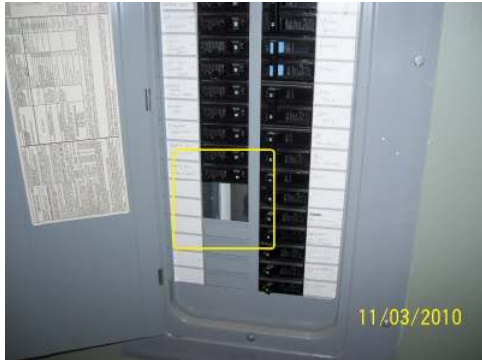
24. There were holes in the cover of the main electrical panel in the laundry room (Picture). The holes could allow a person to reach into the panel and touch live electrical components, which is a shocking hazard. The electrical panel needs to be repaired by a licensed electrical contractor.

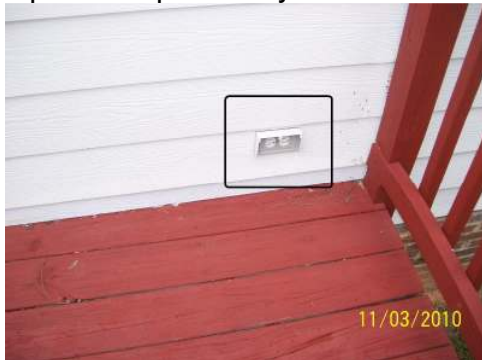
25. There was no Ground Fault Circuit Interrupter (GFCI) protection for the bathroom receptacles. The bathroom receptacles were properly wired and grounded. The lack of GFCI protection creates shocking hazards in the wet environment of the bathrooms. GFCI protection needs to be added by a licensed electrical contractor.
26. The receptacle on the back of the house had no weather cover (Picture), which could allow water into the receptacle and creates a shocking hazard. The receptacle needs to be repaired/replaced by a licensed electrical contractor.

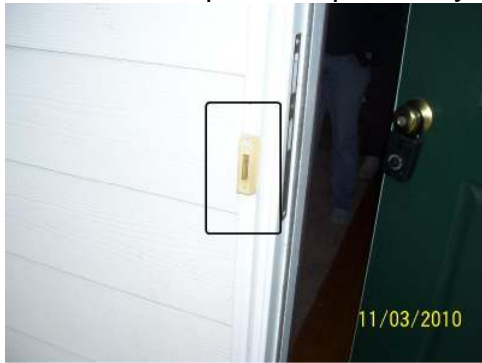
29. The doorbell did not work from the button at the front door. Also, the button was damaged (Picture). Thus, a person could not ring the doorbell to announce their arrival. The doorbell needs to be repaired/replaced by a licensed electrical contractor.

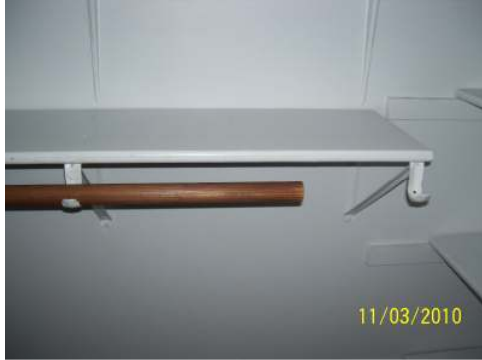
33. The clothes rail in the front-left closet in the bonus room was too short (Picture). Thus, it could fall when clothes are hung on it. The clothes rail needs to be repaired/replaced by a qualified contractor.
