Year / Make / Model:	2006 Chevrolet Corvette Coupe		
Mileage:	16,700		
Options:	6-Speed Auto Trans, Z51 Performance Package, Body Colored Roof, 3LT, QX1 Wheels, Stock Exhaust, Formula One "Pinnacle" window tint on side windows and rear hatch		
Tires:	Michelin Pilot Sport PS2 with 1000 miles on them at the time of test		
Speed / Road Type			
	Baseline (dBA)	After Insulation Install (dBA)	Delta (dBA)
0 MPH Idle	56	55.7	0.3
60 MPH / Concrete	72.3	71.8	0.5
65 MPH / Concrete	73.5	71.6	1.9
70 MPH / Concrete	73.1	71.7	1.4
75 MPH / Concrete	73.6	72.6	1
60 MPH / Asphalt	74.4	74	0.4
65 MPH / Asphalt	74.7	73.3	1.4
70 MPH / Asphalt	74.9	73.9	1
Notes:			
All the runs were hampered by expansion joint noise. Tests should have been run on a continuous stretch of new asphalt for best comparison. Although a minimal improvement in sound level is seen in the data there is a noticeable improvement in sound quality which was heard by both the driver and the sound engineer. The air conditioning and stereo were off during all data collection.

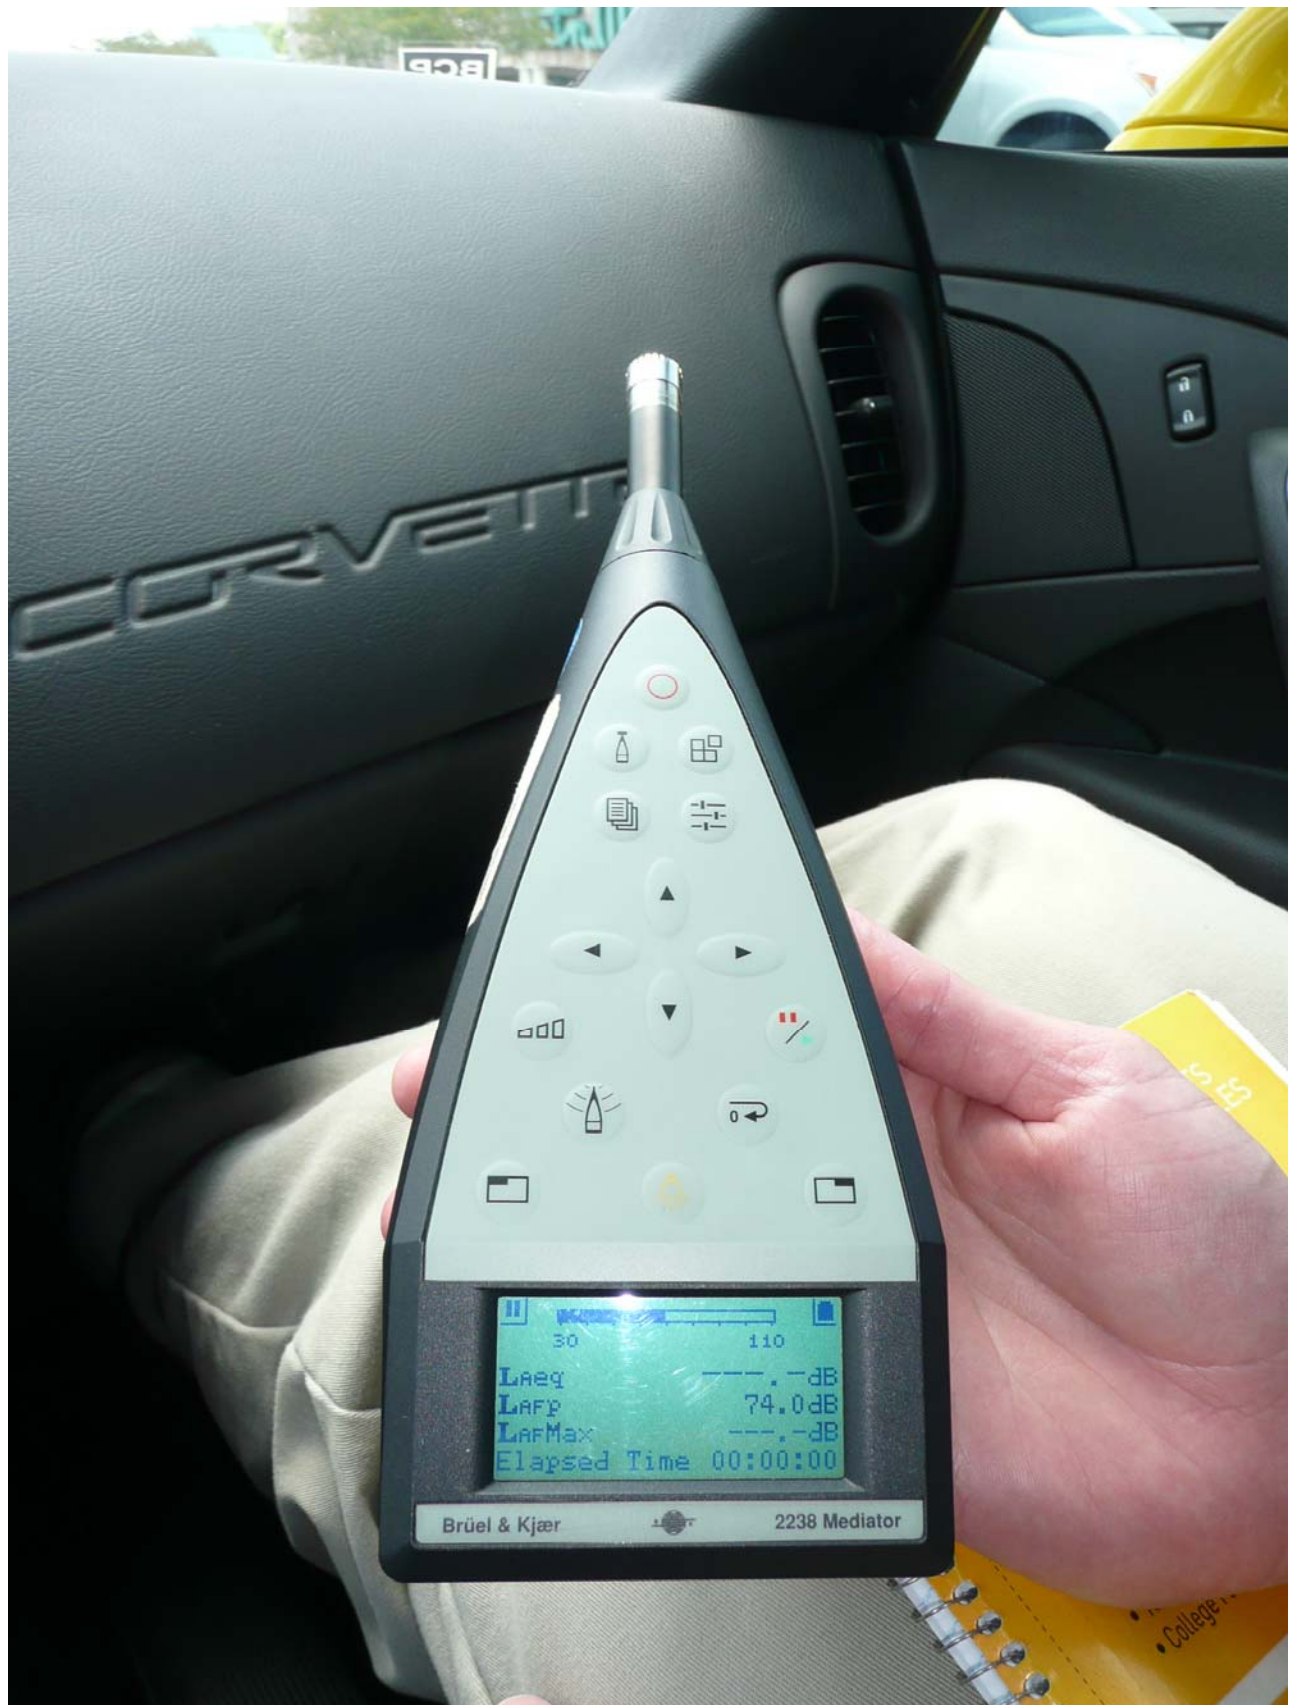
All sound data was taken with the meter shown below.
Meter was held above the center console with the mic at ear level

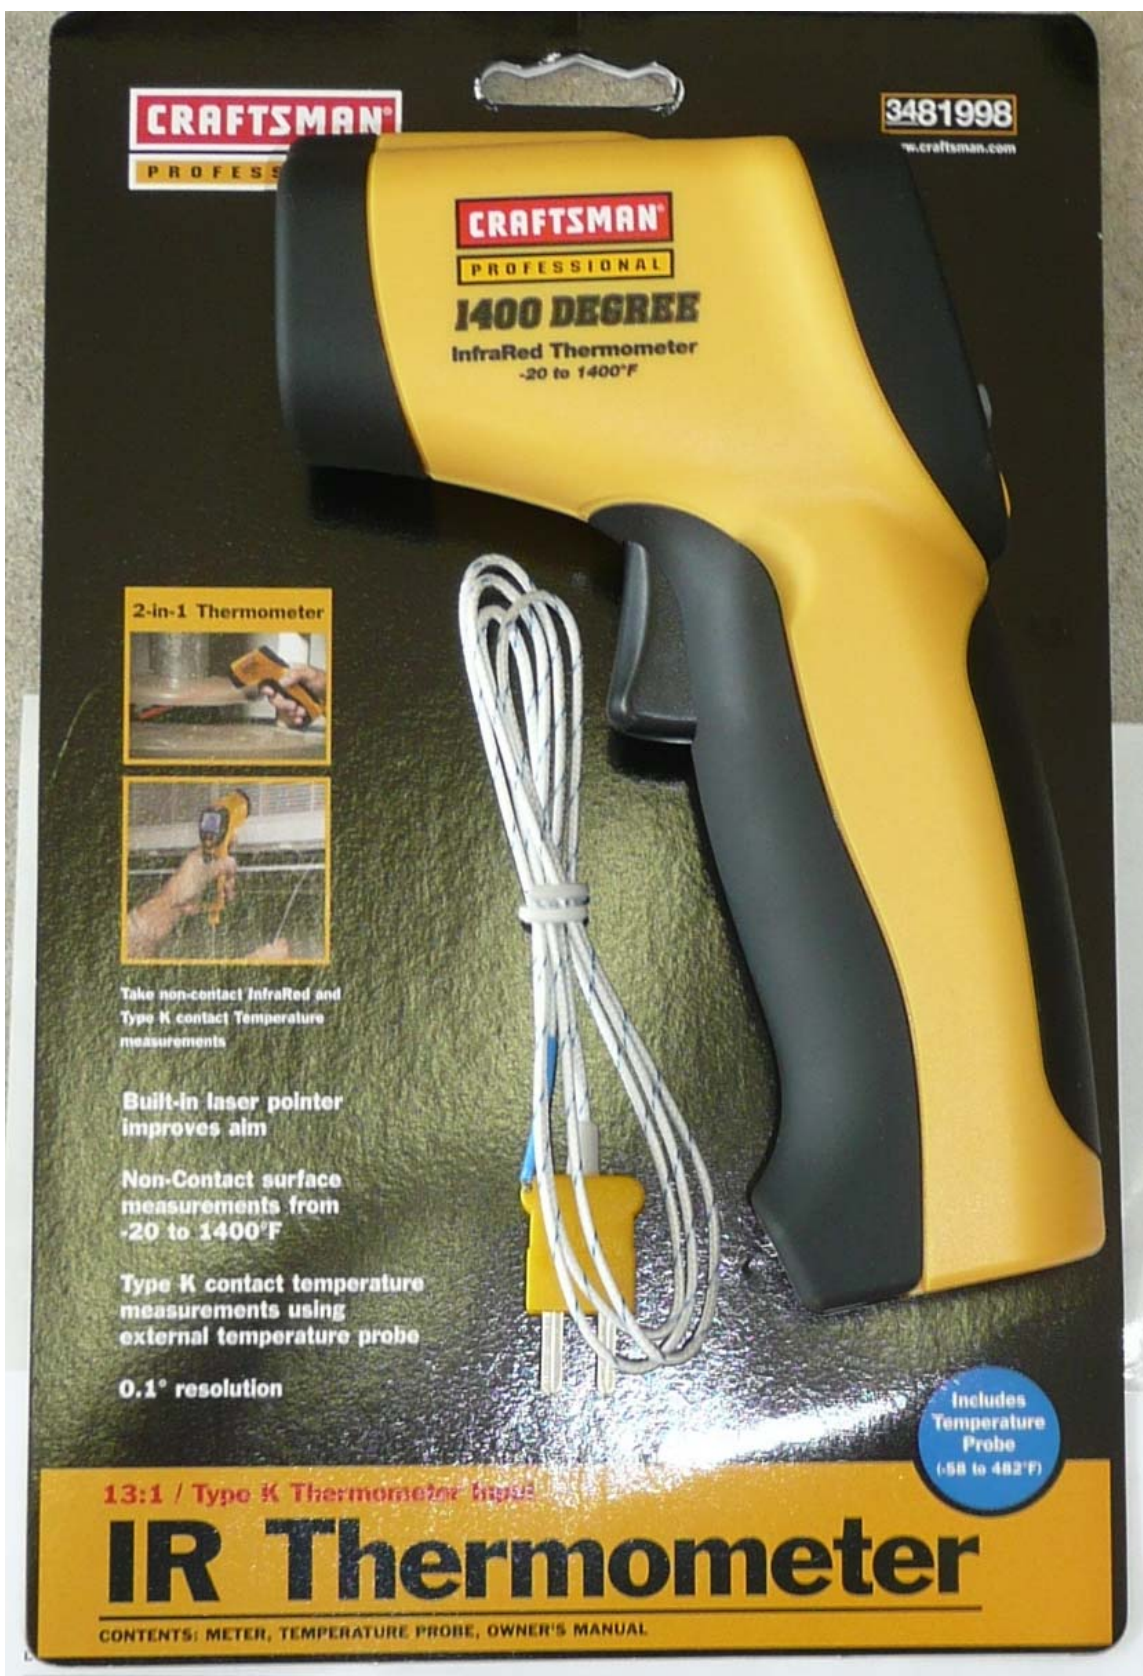
All thermal data was taken with the infrared thermometer shown below. Measurements were taken approximately 1 foot from surface.

Location	Baseline (°F)	After Insulation Install (°F)	Delta (°F)
Center of Driver's Floormat	101.6	90.5	11.1
Center of Pass Floormat	109.4	95.1	14.3
Rear of Driver's Floormat	116.7	100.5	16.2
Rear of Pass Floormat	112.2	96.4	15.8
Dead Pedal	97.7	92.3	5.4
Between Pedals	105.8	95.5	10.3
Middle of Foot Well (Pass)	104.3	96.9	7.4
Below Gas Pedal	113.1	98.7	14.4
Wear Pad (Right of Gas Pedal)	110.8	96.8	14
Mid Xmsn Tunnel (Driver)	113.7	100.5	13.2
Mid Xmsn Tunnel (Pass)	108.5	100.4	8.1
Front of Center Console	148.6	131.1	17.5
Rear of Center Console	150.2	132.2	18
Rear Cupholder	125.9	116	9.9
Front LHS of Rear Mat	126.5	94.8	31.7
Front Middle of Rear Mat	136.2	109.2	27
Front RHS of Rear Mat	120.5	93.7	26.8
Middle LHS of Rear Mat	141	97.1	43.9
Middle Middle of Rear Mat	154.2	104.7	49.5
Middle RHS of Rear Mat	138	95.9	42.1
Rear LHS Cargo Box Top	133.7	98.6	35.1
Rear Middle of Rear Mat	130.4	102.5	27.9
Rear RHS Cargo Box Top	123	97.1	25.9

Notes: Both runs were made during 90°F ambient temperature and included three hours of driving time which allowed the temperatures to stabilize. Air conditioning was set to 72°F and "Auto" mode. Lloyds logoed floormats are installed on both driver and passenger side. There is no rear mat (besides stock carpeting).
